GRAYMONT

Rehabilitation Management Plan

Attunga Limestone Mine

27 February 2024

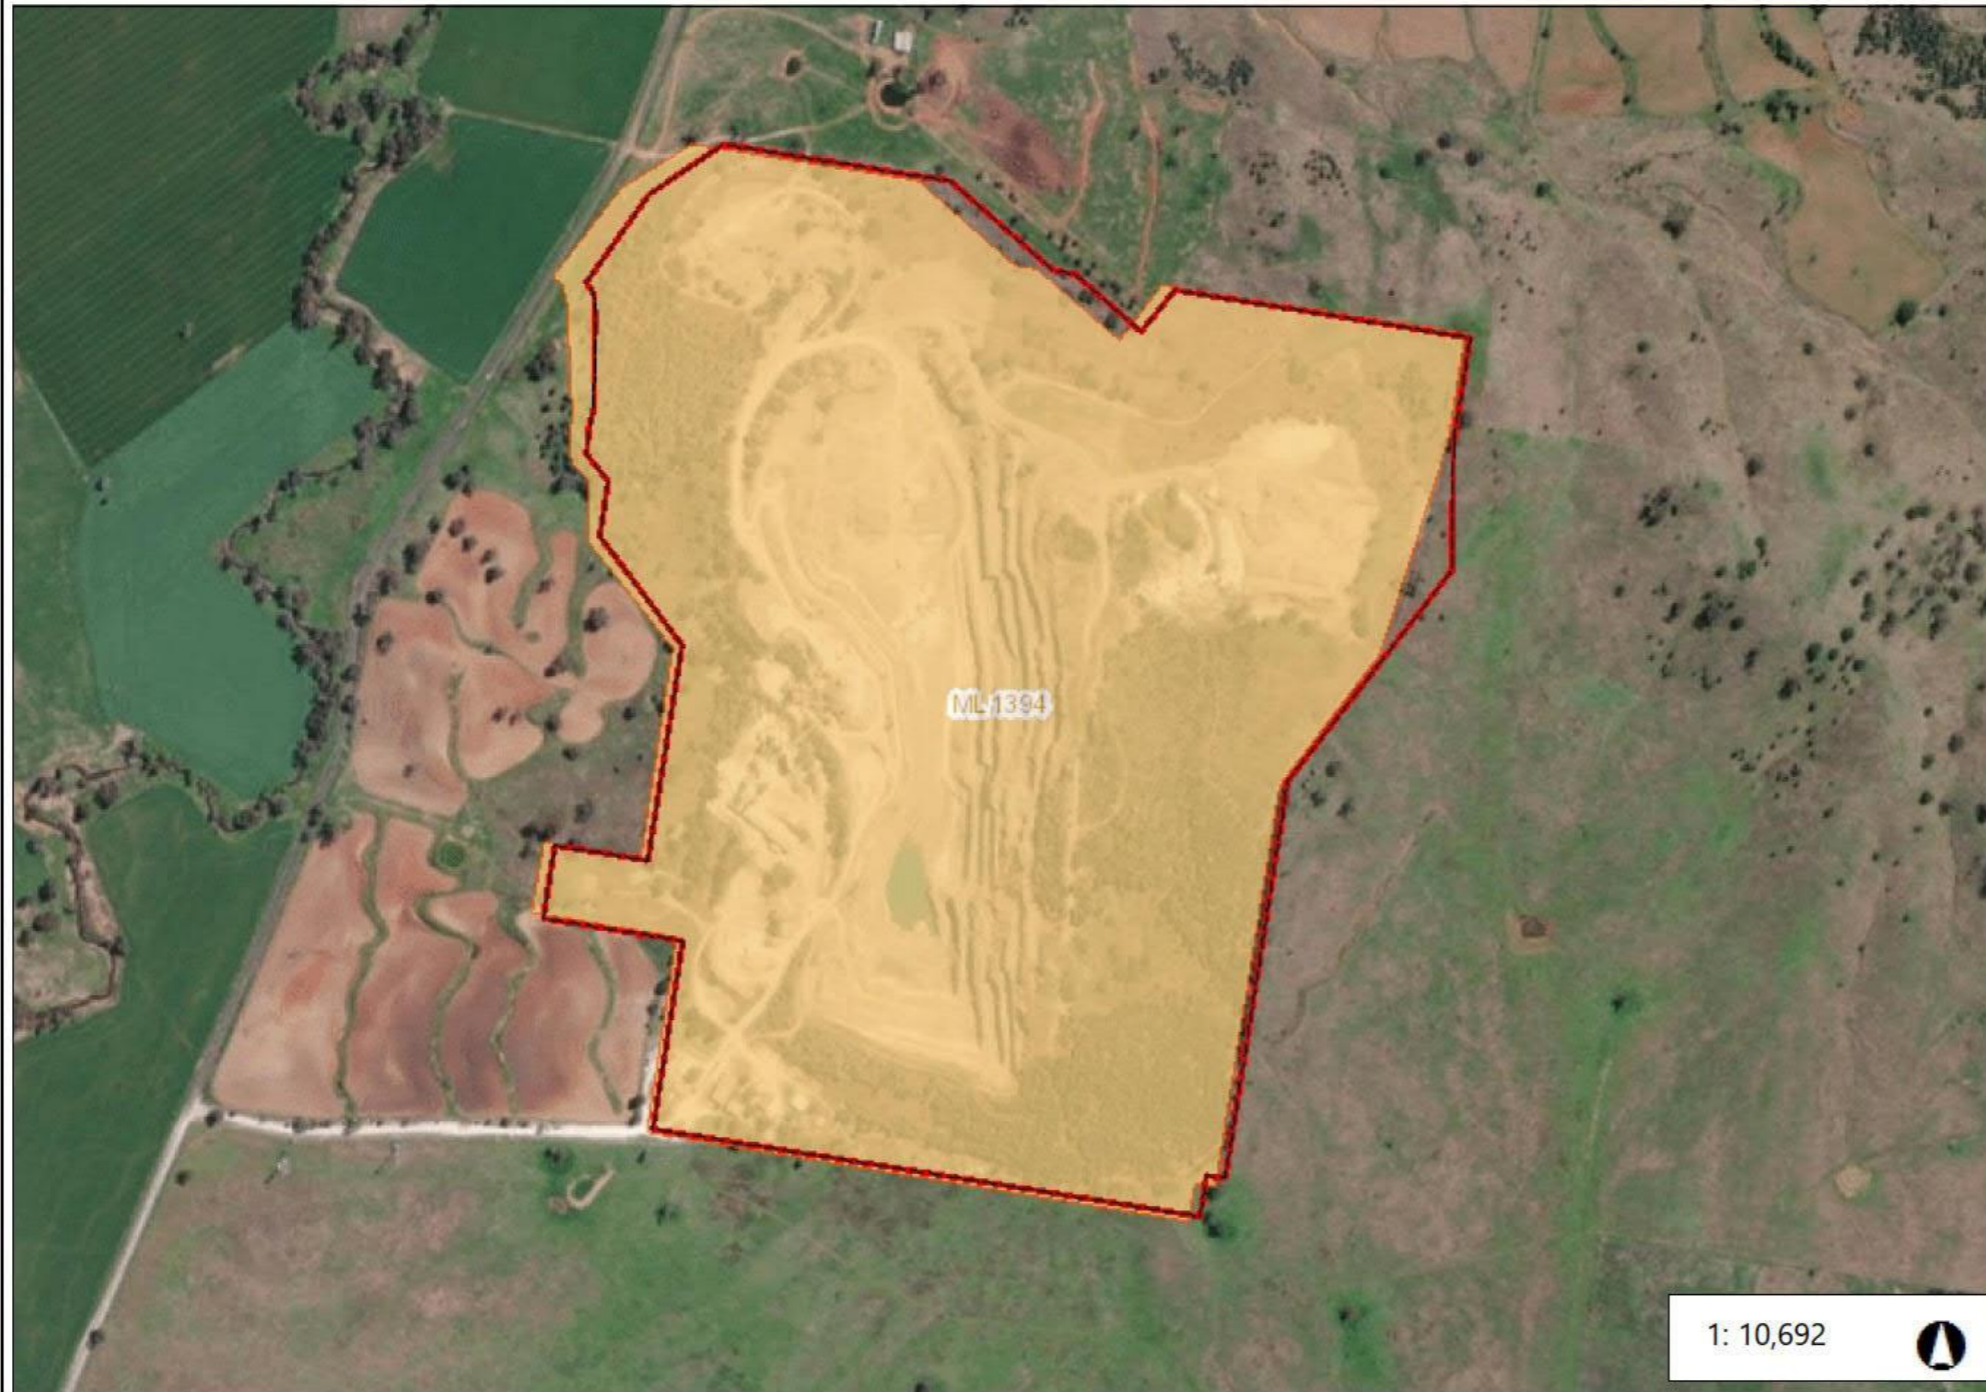
Figure 4: Final landform and rehabilitation plan – Current authorisations

Attunga Limestone Mine Plan 1C: Current Authorisations

- Figure 1A: Final Land Use [Project approval boundary, Final Land Use themes]
- Figure 1B: Final Landform Features [Project approval boundary, Final Landform Features themes]
- Figure 1C: Current Authorisations [Project approval boundary, Current Titles themes]
- Figure 2: Final Landform Contours [Project approval boundary, Final Landform Contours themes].

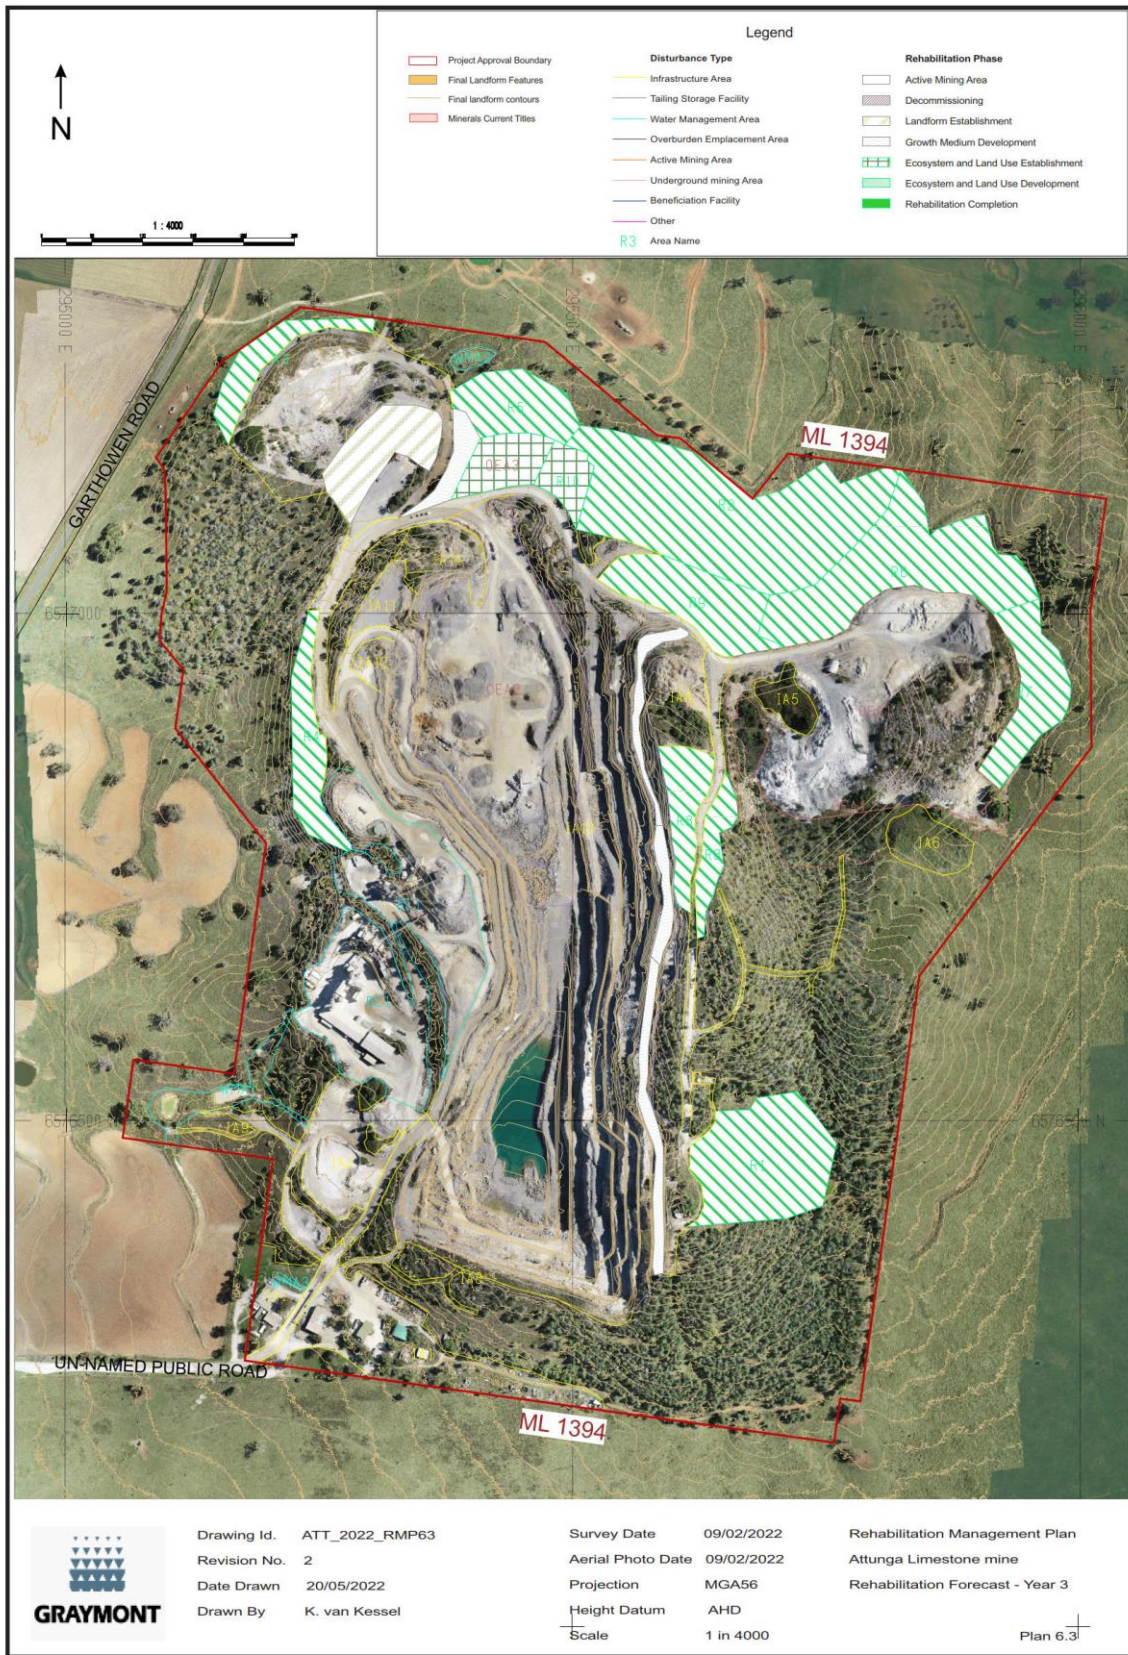
Figure 8: Rehabilitation schedule year 2023

Figure 8 presents the rehabilitation phases for the year 2023. The summary of the proposed rehabilitation phases and activities for 2023 is as follows:

- A part of the infrastructure area identified as IA3 East will commence the Growth Medium Development phase while another section will begin with the Landform Establishment phase
- Overburden emplacement area from R1 to R9 will continue to be in the Ecosystem and Land Use Development rehabilitation phase
- Overburden emplacement area R10 will continue to be in the Growth Media Development phase
- Overburden emplacement area OEA3, which is an extension of R10, will continue to be in the Landform Establishment phase; and
- A section of the final void identified as AMA2 - 433 berm will continue to develop the Landform Establishment phase.

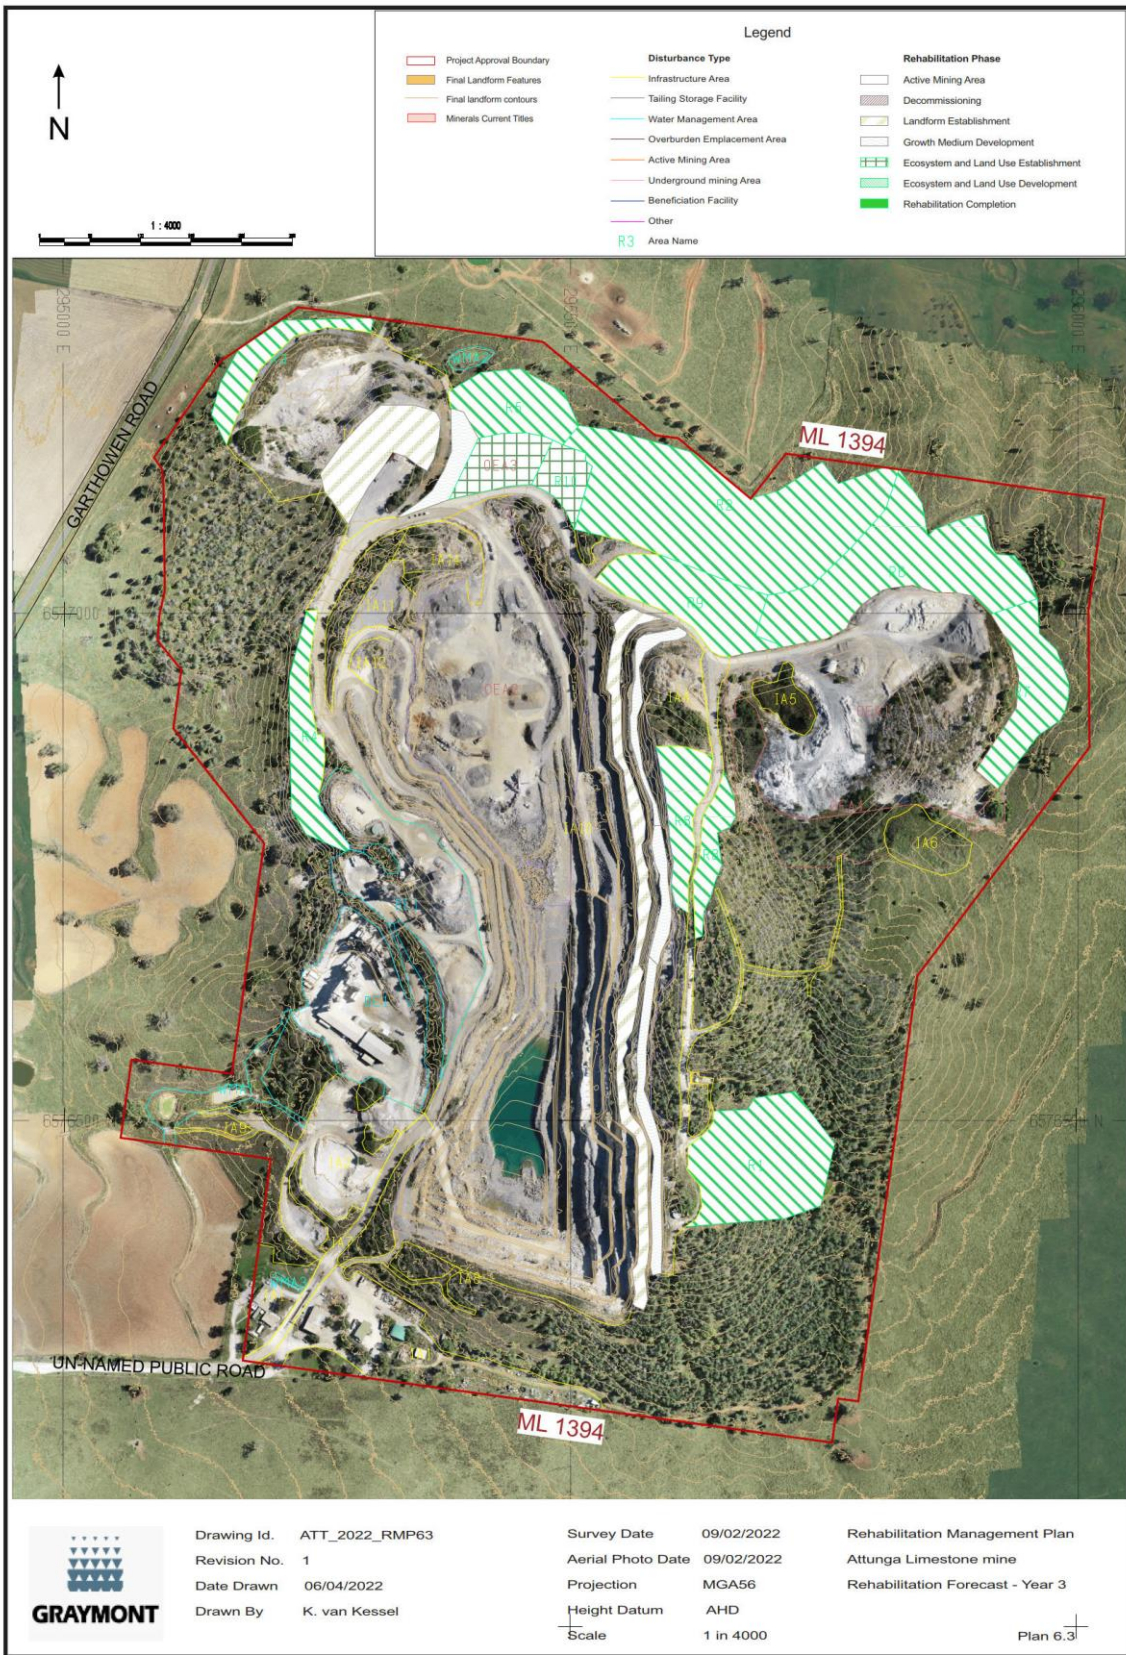
Figure 9: Rehabilitation schedule year 2024

Figure 9 presents the rehabilitation phases for the year 2024. The summary of the proposed rehabilitation phases and activities for 2024 is as follows:

- During 2023 and 2024, stockpile/infrastructure area identified as IA3 East will begin the Landform Establishment and then will continue with the Growth Media Development phase
- The stockpile/infrastructure area identified as IA3 Top bench will comment the Landform Establishment phase in 2024
- Overburden emplacement area from R1 to R9 will continue to be in the Ecosystem and Land Use Development rehabilitation phase
- By the end of 2024, the Overburden emplacement area R10 will be in the Ecosystem and Land Use Establishment phase
- Overburden emplacement area OEA3 will also transition to the Ecosystem and Land Use Establishment phase in 2024
- In 2024, the final void identified as AMA2 – 433 berm will begin the Growth Media Development phase; and
- The final void identified as AMA2 – 422 berm will begin the Landform Establishment phase in 2024.

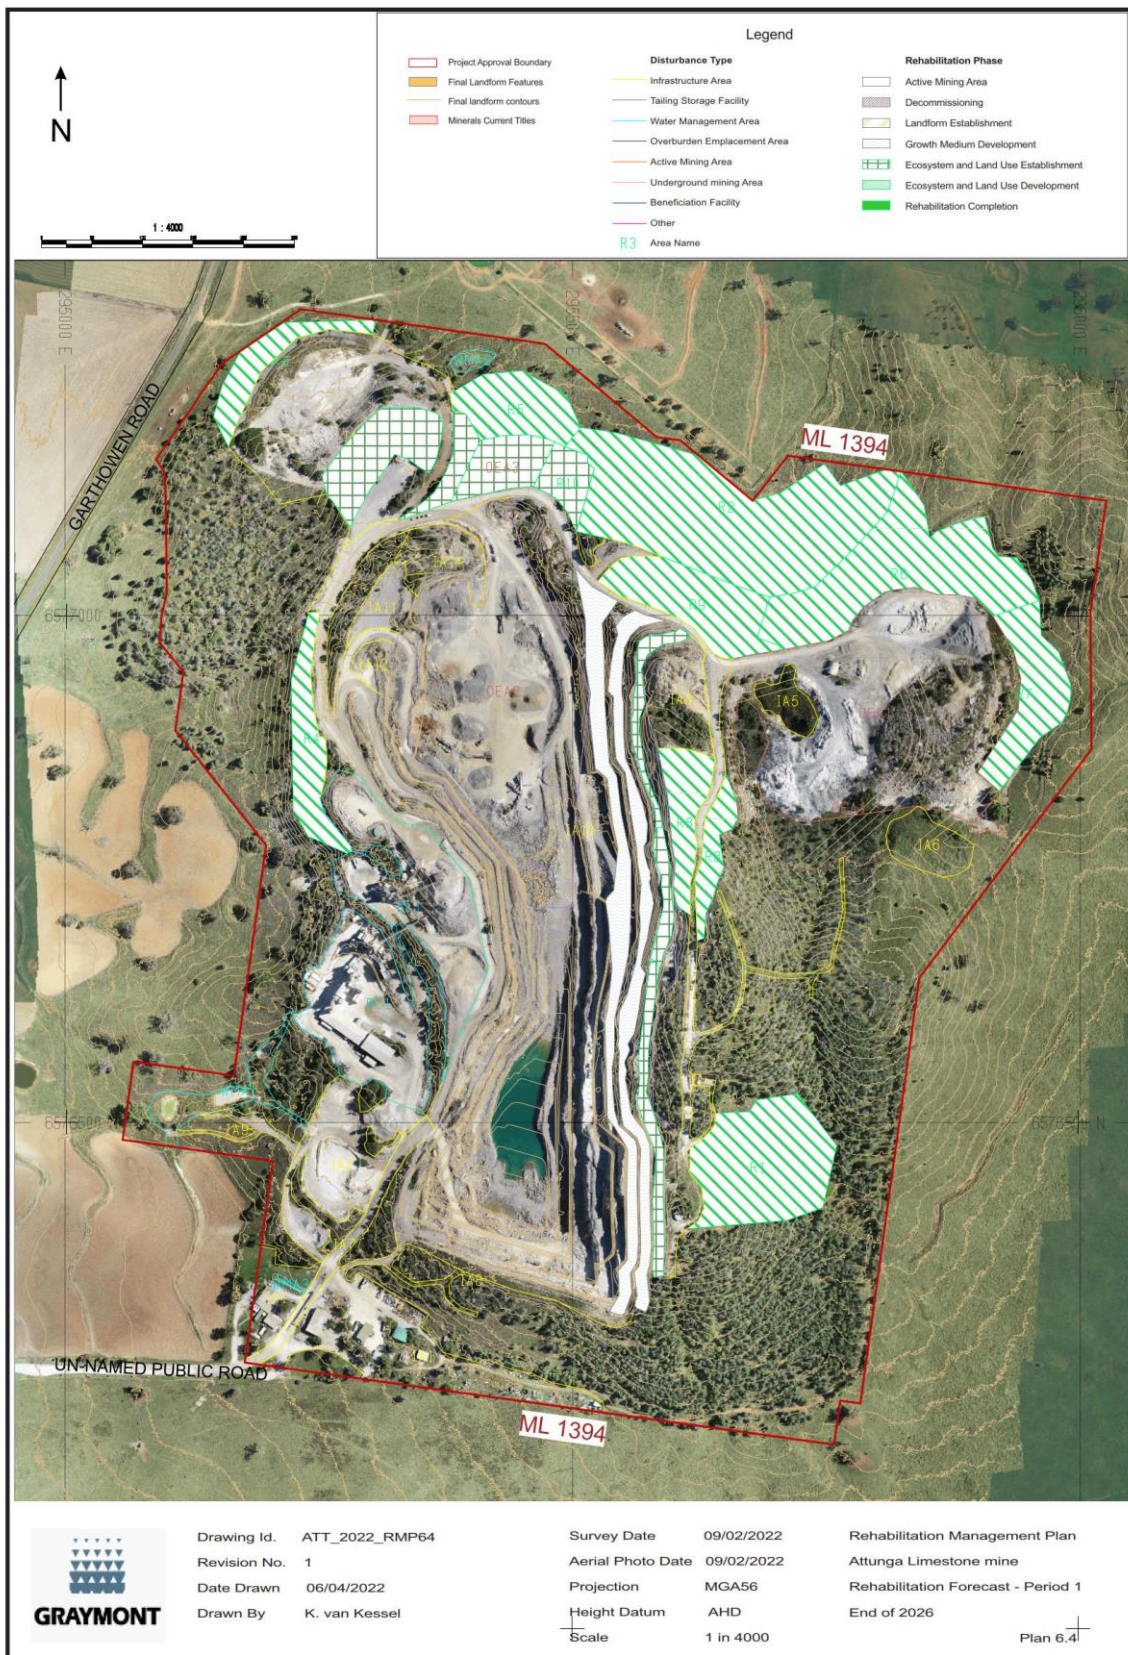
Figure 10: Rehabilitation schedule year 2026

Figure 10 presents the rehabilitation phases to be completed by the end of the year 2026. The summary of the proposed rehabilitation phases and activities is as follows:

- Stockpile/infrastructure area identified as IA3 East and IA3 Top bench will be in the Ecosystem and Land Use Establishment phase
- Overburden emplacement area from R1 to R10 and OEA3 will continue to be in the Ecosystem and Land Use Development rehabilitation phase
- The final void area identified as AMA2 – 433 berm will be the in Ecosystem and Land Use Establishment phase; and
- The final void area identified as AMA2 – 422 berm and AMA2 – 411 East berm -411 level will be in the Growth Media Development phase.

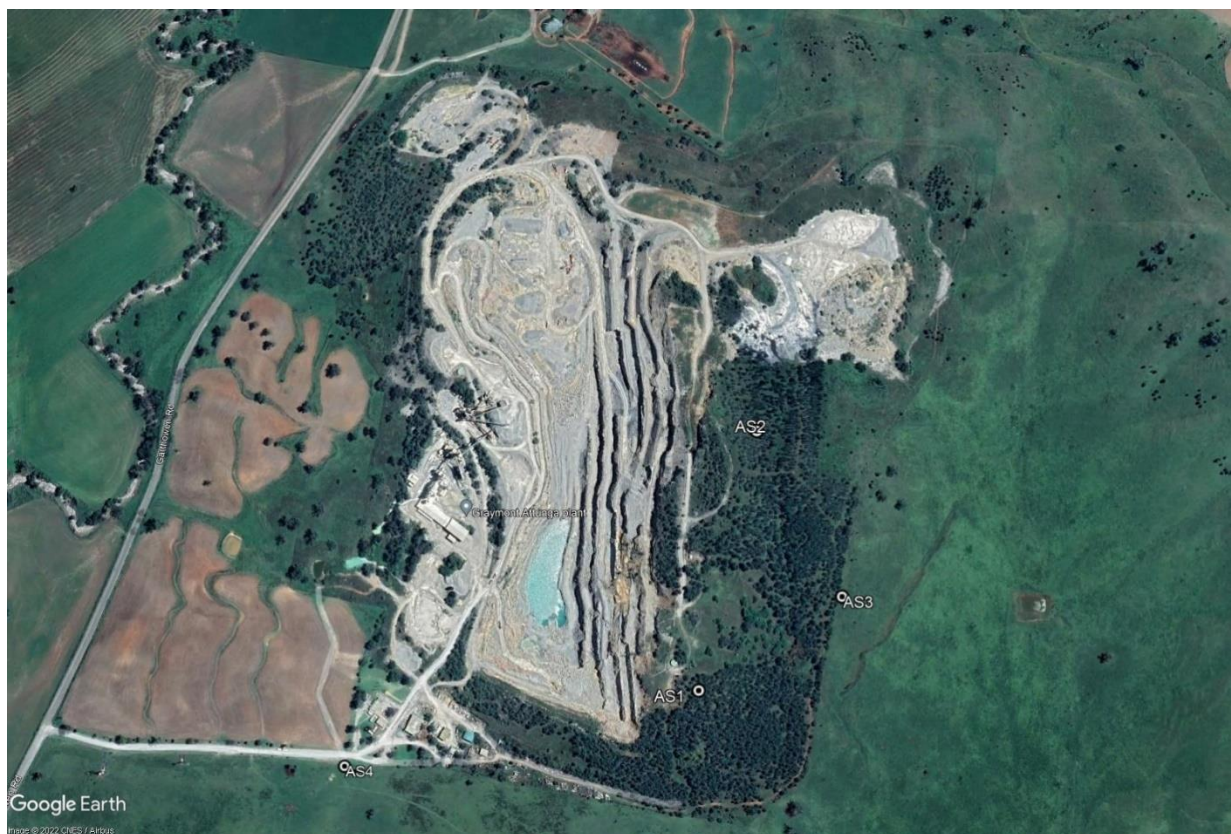
Figure 14: Analogue sites

Figure 14 shows the four analogue sites.

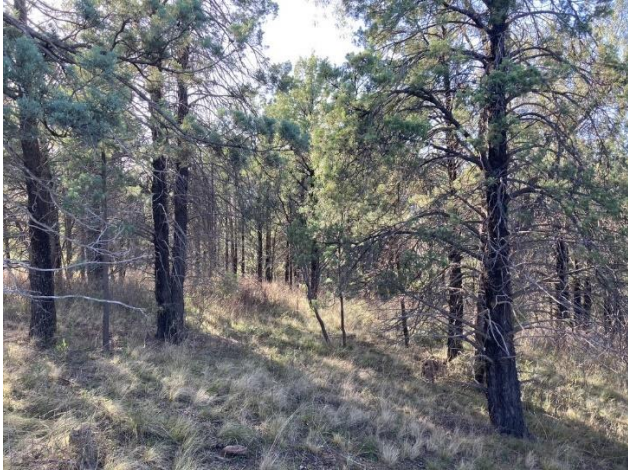
Table 16: Analogue site 1

Coordinates	30.92842° S, 150.86116° E
Ecosystem Type	Black Cypress Pine Forest.
Canopy / Emergent	Canopy is dominated with Black Cypress Pine (<i>Callitris endlicheri</i>) and wattle tress (<i>Acacia pycnantha</i>) by approximately 90% and 10%, respectively.
Shrub / Understory Layer	Primarily introduced species such as milkweed, dandelions, verain, horehound and common nightshade. These species are common weed species in the region and should be controlled.
Ground / Herb Layer	90% groundcover dominated by tussock grasses. There is also minor gravel and other herbaceous plants.
Fallen timber (Coarse woody debris)	Very low – Occasional thin (5-10mm diameter) sticks and rare medium (10-50mm diameter) sticks.
Landform	Moderately inclined upper slopes with a gradient of approximately 20%.
Soil Conditions	No visible erosion on site. A soil survey was no undertaken for this analogue site.

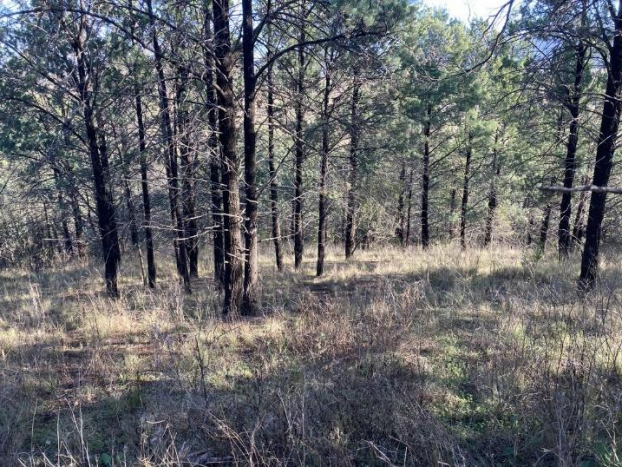
Table 17: Analogue site 2

<p>Coordinates</p>	<p>30.92647° S, 150.86193° E</p>
<p>Ecosystem Type</p>	<p>Black Cypress Pine Forest.</p>
<p>Canopy / Emergent</p>	<p>Canopy cover is around 60 to 70%, dominated by Black Cypress (<i>Callitris endlicheri</i>), White Box (<i>Eucalyptus albens</i>), and Wattle (<i>Acacia pycnantha</i>) trees.</p>
<p>Shrub / Understory Layer</p>	<p>Primarily introduced species such as milkweed, dandelions, verain, horehound, captures, common nightshade, among others. These species are part of the native ecosystem of the region; however, they need to be controlled.</p>
<p>Ground / Herb Layer</p>	<p>95% groundcover dominated by tussock grasses. There is also moss and other type of herbaceous plants. This site has a rockier ground than analogue site 1.</p>
<p>Fallen timber (Coarse woody debris)</p>	<p>Small, medium, and large sticks, with some large logs and fallen branches.</p>

<p>Landform</p>	<p>Moderately inclined to steep upper slopes with a gradient of approximately 25 to 30%.</p>
<p>Soil Conditions</p>	<p>No visible erosion on site. A soil survey was not undertaken for this analogue site.</p>

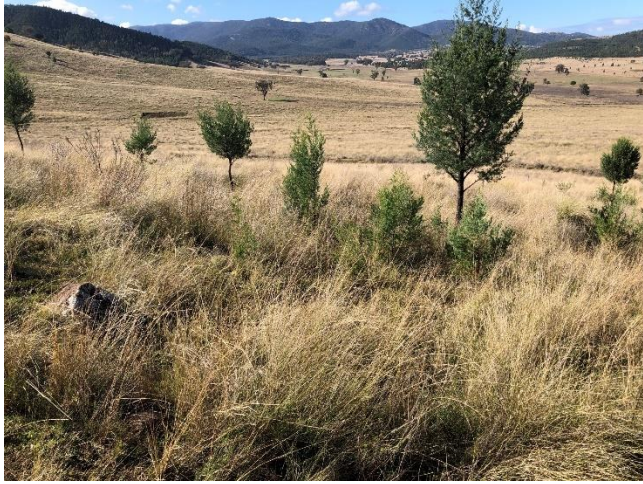
Table 18: Analogue site 3

Coordinates	30.92736° S, 150.86317° E
Ecosystem Type	Grazing woodland
Canopy / Emergent	Canopy cover is around 20% dominated by Black Cypress (<i>Callitris endlicheri</i>) which seems to be returning to this site.
Shrub / Understory Layer	A mixed pasture of native and introduced species.
Ground / Herb Layer	100% groundcover dominated by tussock grasses. Rocky cover less than 5%.
Fallen timber (Coarse woody debris)	None visible at the time of inspection.
Landform	Lower slope with a gradient of approximately 10 to 15%
Soil Conditions	No visible erosion on site. A soil survey was no undertaken for this analogue site.

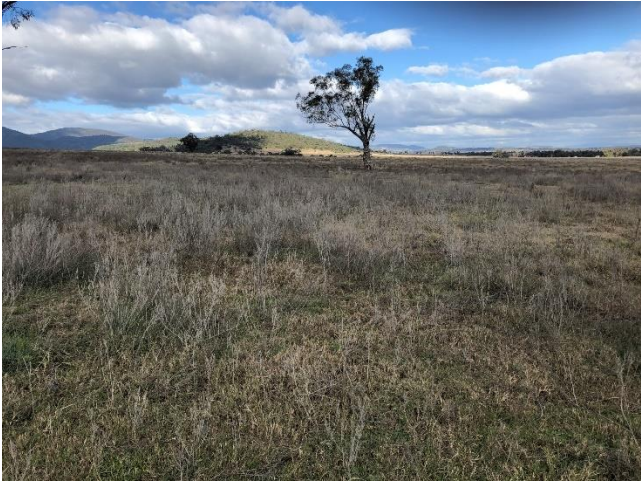
Table 19: Analogue site 4

Table 19 shows a selected analogue site for agricultural – grazing final land use. This site is located outside the project boundary at the south-west direction.

<p>Coordinates</p>	<p>30.92951 S, 150.856040 E</p>
<p>Ecosystem Type</p>	<p>Grazed pasture/Grassland</p>
<p>Canopy / Emergent</p>	<p>Canopy cover is around 5-10% dominated by Eucalyptus trees.</p>
<p>Shrub / Understory Layer</p>	<p>A mixed pasture of native and introduced species.</p>
<p>Ground / Herb Layer</p>	<p>100% groundcover dominated by tussock grasses and foreign species including onion weed. Rocky cover less than 5%.</p>
<p>Fallen timber (Coarse woody debris)</p>	<p>None visible at the time of inspection.</p>
<p>Landform</p>	<p>Mid slope with a gradient of approximately 3%</p>
<p>Soil Conditions</p>	<p>No visible erosion on site. A soil survey was no undertaken for this analogue site.</p>
